# INVESTIGATION OF STRUCTURE OF GASHOLDER WITH 5000 m<sup>3</sup> CAPACITY, DAMAGED DURING EXPLOITATION

Dimitar V. Dakov<sup>1</sup>, Lyubomir A. Zdravkov<sup>2</sup>

*Science conference UACG' 2008*

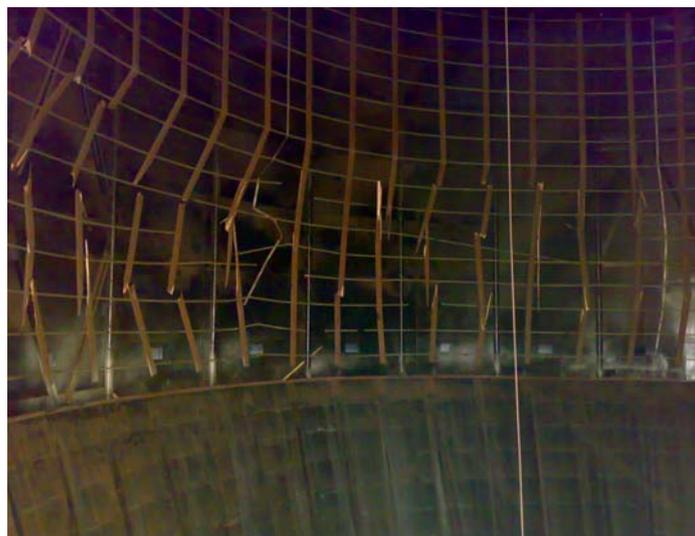
According to the information from the persons in charge with the exploitation the gasholder failure occurred in the night between 1 and 2 of July. Immediately before the failure the gasholder has been filled up to  $60 \div 70\%$  from the useful volume. The internal pressure of the closed volume has decreased quickly and the moving ceiling collapsed on the bottom of the gasholder with the big thunder. During the inspection made after the failure it became clear that the supporting grating is destructed and rubber membrane is punctured. /fig. 4/

- The supporting grating had the entire translation in the south-east direction and the general displacements are  $200 \div 600$  mm.
- Eight of the steel rings located in the lower part of the grating are torn. Almost all rings are torn on two places positioned in the opposite directions. As a whole the places of tearing coincide with the direction of dislocation.
- All tears of the steel rings (pipes  $\text{Ø}31,8 \times 2,6$ ) are in the area of the butt welding joints. /fig. 5/
- Butt welds, connecting the different parts of the rings, have been executed on the site without additional internal rings. The pipes have been delivered hot galvanized on their whole length.
- Considerable part of the vertically positioned boards, located in the area of rings tearing is broken.
- The rubber membrane is punctured on two places and the length of the breaks does not exceed 120 mm.

fig. 4 Part of the damaged supporting grating

- Not reported additional tensions in steel rings – caused by local bending, temperature impact ect.
- Decreased strength of the mounting butt weld joints connecting different parts of the rings.
- Deviation from the projected position of the telescopic column of supporting grating.
- Insufficient stiffness of fixing of telescopic column to the gasholder roof.

- To prepare project for repairing works of gasholder after an entire analysis of the whole bearing construction;
- To make a review of the project of supporting grating in which the results of current research shall be taken into consideration;
- To build atomized system for control management and analysis of parameters for gas generation /quantity of gas, pressure, level of filling/ by using of indicators in an explosive danger environment.

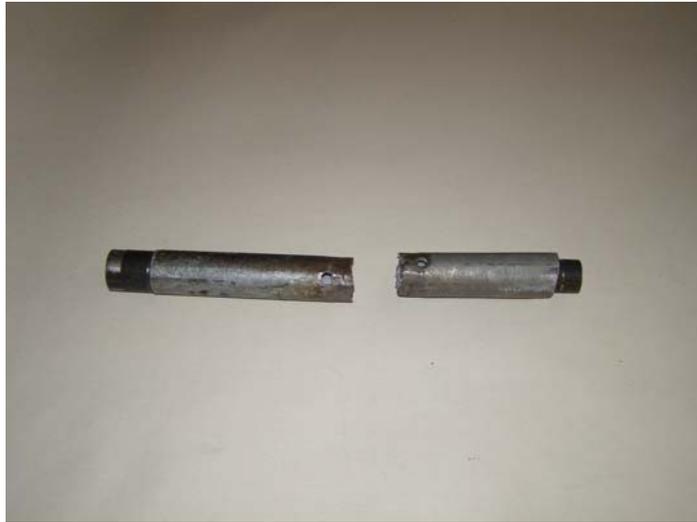
fig. 5 Broken butt weld of steel ring

An experimental check for the welding joints strength shows that it is 70% from the strength of the main metal of pipes. In the same time, the calculated strength of one butt weld in the steel pipe is bigger than the relevant maximum of the calculated effort mentioned in the project.

The main reason for the relatively low strength of the butt weld joints is technological, referred in the project solution. It is stipulated to butt weld on spot galvanized steel pipes even without a prescription of constructive detail for the execution of this joint. It is well known that zinc galvanization deteriorates the quality of the welding work and makes lower the strength of the welding joint.

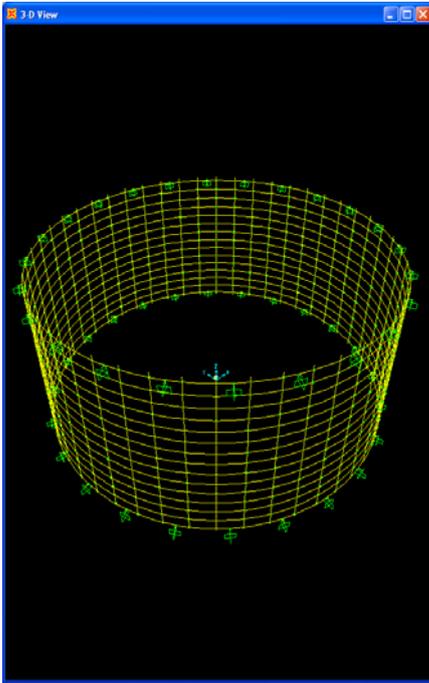
In order to obtain enough reliable theoretical data for status of supporting grating when it is under pressure it has been prepared a three dimensioned calculating model with software SAP 2000 /fig. 6/. During the calculating modeling we looked for correspondence with the real construction. For example we accepted for the upper and the lower steel rings pin joints between  $15^{\circ}$  and other intermediate rings are without external supporting but the are connected between them self by the elements with bending stiffness located vertically on the ring at a distance of  $7,5^{\circ}$ . Those vertical elements correspond on the soft wood boards in the supporting grating.

fig. 6 Calculating model

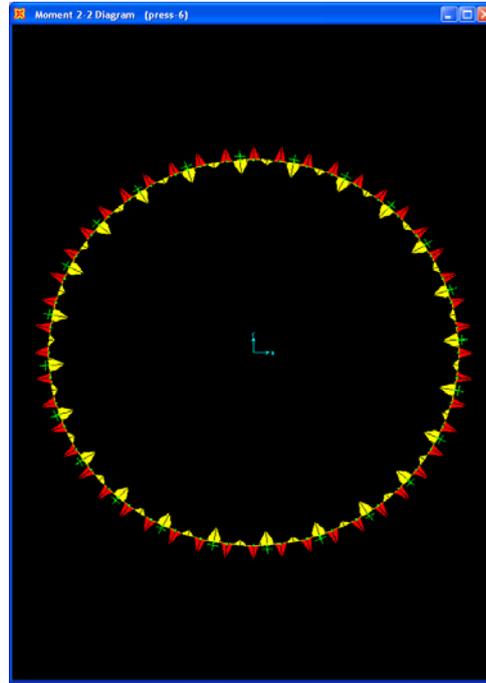
The three dimensioned calculating model gives the opportunity to estimate the grating connection between the horizontal steel elements /rings/ and the vertical wooden elements. As a result of the grating connection under the influence of inside gas pressure transferred through rubber membrane they appear in the rings not only tension axe forces /as accepted in the “Passavant-Roediger” project/ but also bending moments.

fig. 7 Diagram of the bending moments by the loading of over pressure

1. Normal tensions in the steel rings calculated through the formula of the “cauldron” in the realized project are considerably lower than those determined by the three dimensioned calculating model;
2. The accepted cross section of the steel rings / $\text{Ø}31,8 \times 2,6$ / is not sufficient for providing their needed bearing capacity;
