REHABILITATION AND LONG TIME BEHAVIOUR OF ASPHALT CONCRETE LINED RESERVOIRS AND DAMS

P. Tschernutter¹

Keywords: rehabilitation, asphalt concrete linings, dams

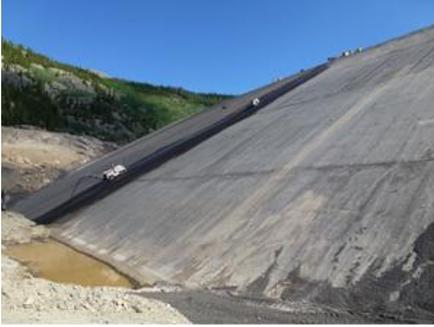
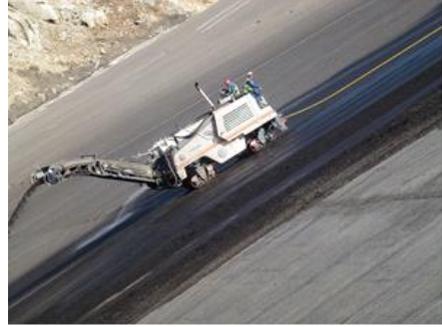
Fig. 2. Vertical milling of the existing ACF

The rehabilitation of an old lining includes basically milling-off the old sealing layer to a certain depth, cleaning the surface with compressed air, spraying of an emulsion and applying a new impervious layer – at least 7 or 8 cm thick.

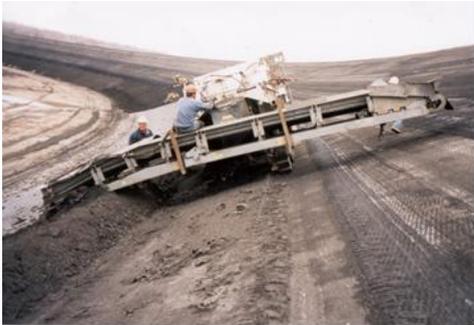
Fig. 3. Horizontal milling of the existing ACF

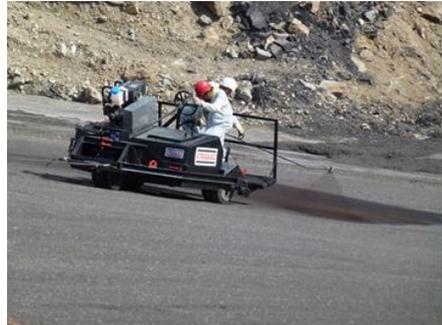
Fig. 4. Spraying of emulsion on top of the milled surface

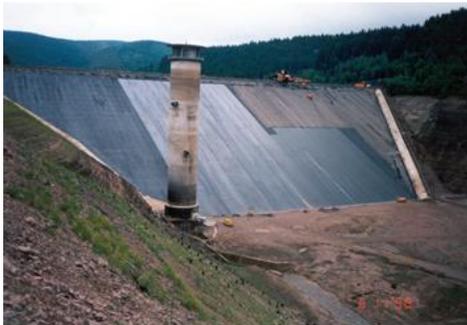
Fig. 5. Rehabilitation of an asphalt concrete faced dam, vertical placing

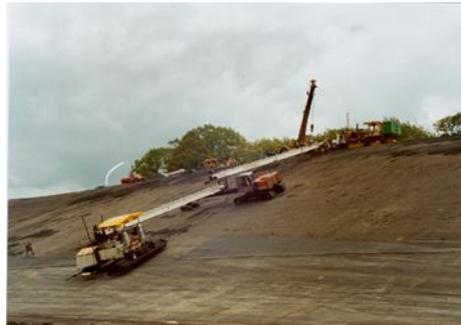
Fig. 6. Horizontal placing of the new asphalt concrete sealing

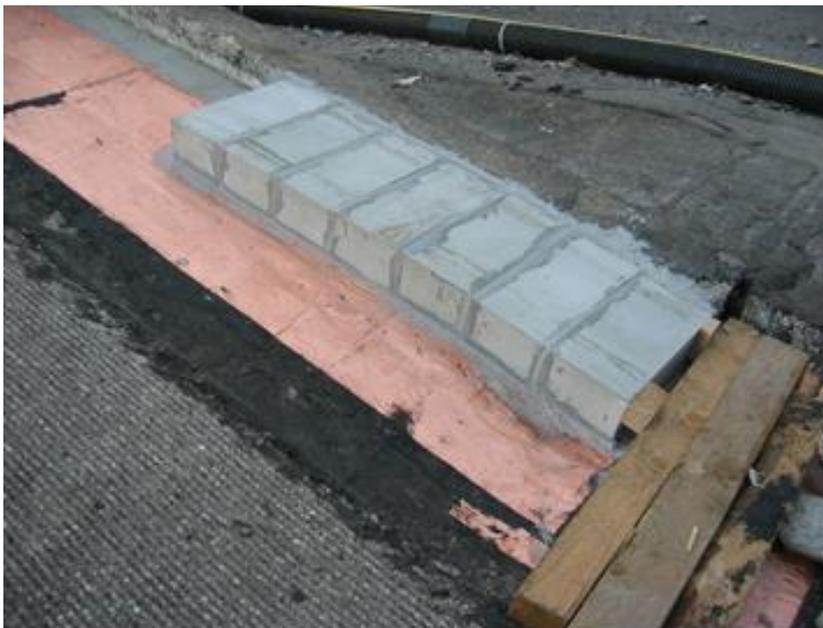
Fig. 7. Connection between ACF and plinth with copper water stop and bricks
