ACOUSTIC ADAPTATION OF PERFORMANCE AND LECTURE SPACES IN HISTORICAL BUILDINGS

Z. Madzharova¹, A. Kirechev²

Historical buildings are an architectural form of heritage where unique aesthetic spaces can be adapted to host new functions. This is a case study of a national heritage building in Sofia, Bulgaria, originally built as a private house and atelier for a famous sculptor. The building is currently adapted as a cultural center with a theatrical performance hall, an exhibition/lecture hall and a small music hall. The spaces need acoustic corrections in order to provide adequate performance. Due to aesthetic and historical reasons, sound-absorbing panels should be designed and imported in the space in an appropriate manner. Room acoustic simulation software is used to locate the most effective positions of sound-absorbing panels, to reduce reverberation time and improve speech intelligibility.

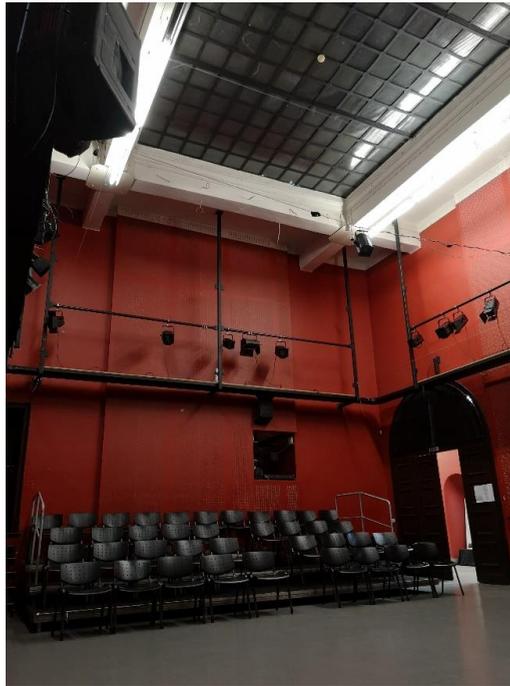
The Large Studio, Fig. 3 and 4, has a clear rectangular plan, large window openings providing natural light and illuminating the former working area. The space also has roof glazing over the bearing metal structure. The combined rehearsal room represents two connected rectangular volumes with floors and ceilings at different levels, respectively. All the walls are solid brick-built, plastered both in interior and exterior. During the adaptation in 2004 most of the original structures of the walls had been preserved. Only the Large Studio breaks the original wall structure in an attempt to acoustically interfere with placing acoustic perforated panels on the walls for sound absorption. During the reconstruction, the original double-glazed window frames have been preserved, either with wooden or metal structure. There are curtains in front of the windows in the Large Studio.

Figure 3. The Large Studio

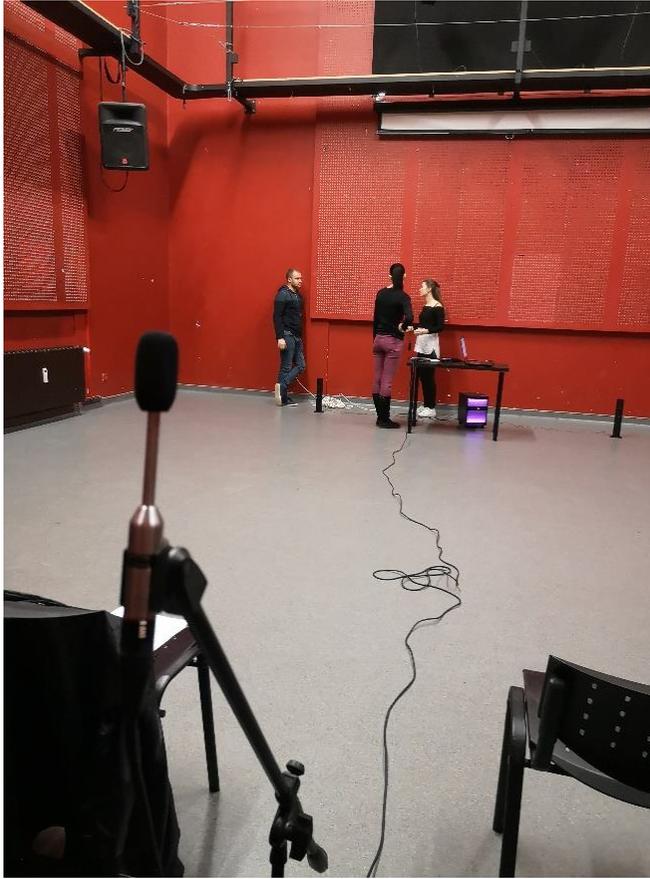
For the Large Studio and the Small Concert Hall the room dimensions are presented in Table 1. Fig. 4 shows the Large Studio during acoustic measurement recording, with the sound source and the microphone. The measurements were taken in the morning during weekends in order to minimize the impact acoustic disturbance from the surrounding area. During the recordings the background noise varied around $LeqA = 40$ dBA.

Figure 4. The Large Studio – measurements

For each of the two examined spaces the acoustic measurements were carried out using an omnidirectional spherical source fed with a SWEEP signal. The impulse responses were detected and analyzed for the specific use of the room. The sound source was placed in each room, corresponding to the performance position, and the microphones measurements were in different points in the audience area at a typical ear height (1,2 m) to obtain the average value of the received sound. The acoustic parameters were measured in accordance with BREEAM Standards [5].

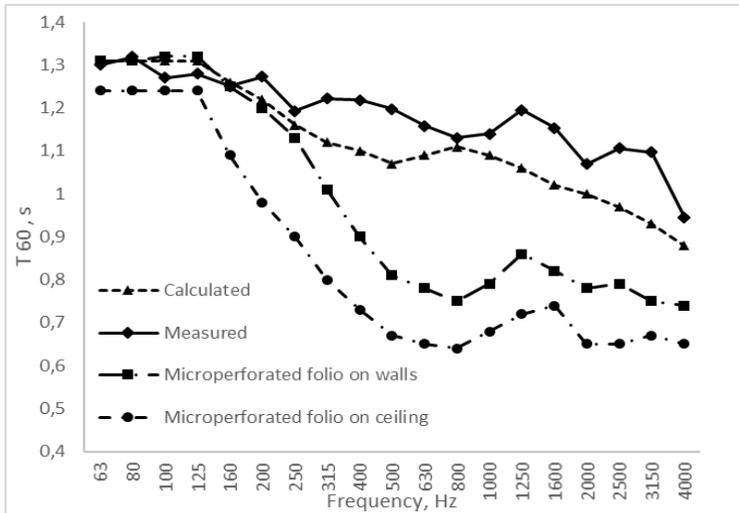
The average measured reverberation time T_{60} for the Large Studio is 1,15 s and the insertion of the absorbent materials decreases it to approximately 0,8 s, corresponding to the volume of the space and the new function. Fig. 5 shows the values of T_{60} measured on site, the calculated T_{60} from the calibrated virtual model, the calculated T_{60} value after inserting a surface of a transparent microperforated folio as an acoustic correction on the vertical walls, or when the same equivalent area of the material is placed below the ceiling. The type of the absorbent material was chosen for its acoustic characteristics and impact in space as a transparent and unobtrusive object, revealing the original interior of the architectural monument.

Figure 5. Large Studio, values of T_{60} (measured, calculated, with 36 m² microperforated folio on walls, with 36 m² microperforated folio below ceiling)

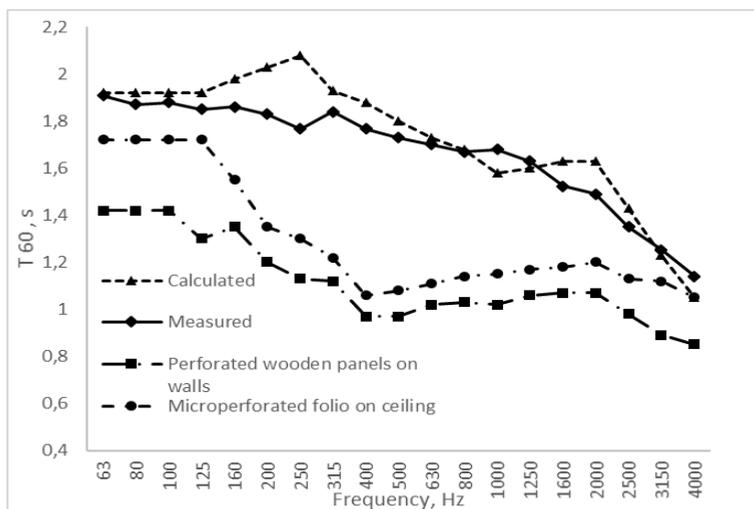
For the acoustic correction of the Small Concert Hall the same approach was applied. The average measured reverberation time T_{60} is 1,67 s and the intervention decreases it to approximately 1,2 s, corresponding to the volume of the space and the newly assigned function according to the BREEAM standards [5]. The selected material for the wall treatment was wooden panels based on their performance as an absorber in the lower frequencies compared to the microperforated foil. For the ceiling intervention the wooden panels were not appropriate in reference to the interior of the space and therefore the microperforated foil was chosen.

Figure 6. Small Concert Hall, values of T_{60} (measured, calculated, with 16 m² perforated wooden panels on walls, with 16 m² microperforated folio below ceiling)
